# Site and Reach Assessment Union River At SR 300

Work Order MT 0100 Garrett W. Jackson, Hydrologist WSDOT Environmental Services, Watershed Management Program January, 2008

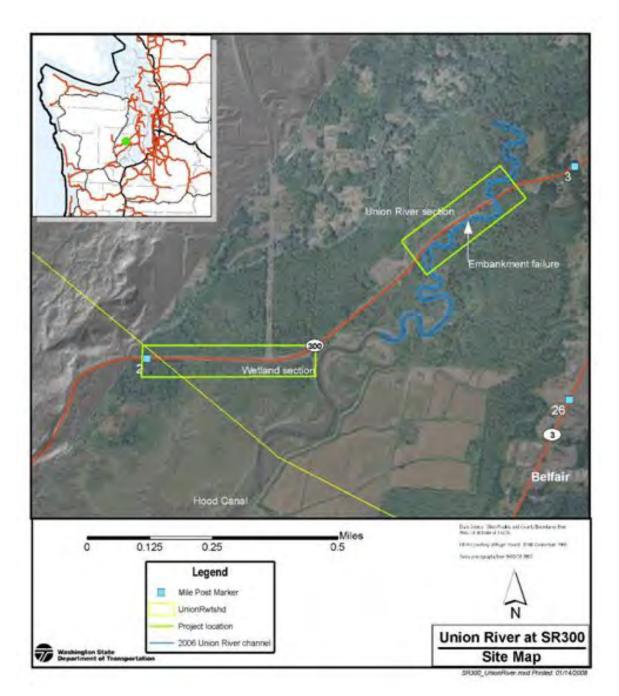
Figure 2. Union River bridge and vicinity

The bridge is situated between two river meanders (Figure 2). The underside of the bridge deck is about seven feet above the streambed. The bridge deck is supported by two rows of wooden piers, making a three-span bridge. Each row has four individual creo-sote-treated timbers. The piles are driven into the floodplain between 30 and 44 feet (State Department of Highways 1960). The approaches are supported by timber cribbing. The west bridge approach also has a concrete abutment wall with a spread footer that is located in front of the timber cribbing. There are sawn-off piles in the channel under the bridge, indicating that an older bridge was located here, or that the current bridge has been modified from its original configuration.

About 500 feet downstream from the bridge, the river is wider and flows past a series of relatively small debris jams that spread flow. The debris is forcing the thalweg against the highway embankment about 300 feet west of the bridge (Figure 6). Riprap has been placed along the road embankment, but it is being undermined. The road fill adjacent to the pavement edge is slumping, as indicated by tension cracks and small scarps (up to six inches). About 325 feet of road embankment are threatened by erosion. Riprap is not present along this entire length. Figure 7 shows a close-up of the Union River section and key features.

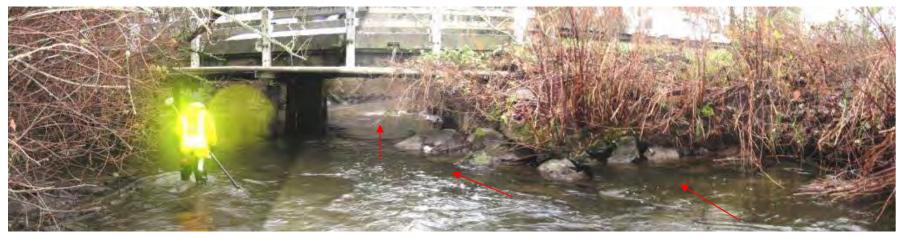
# Figure 4. View looking downstream toward Union River bridge.

Note angle of attack on revetment. Red arrows indicate direction of flow.

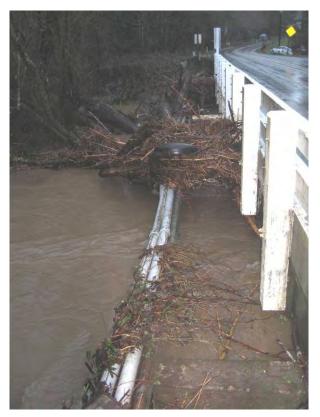
Figure 5. Wood debris on upstream side of Union River Bridge.

Note utility conduit paralleling the bridge.

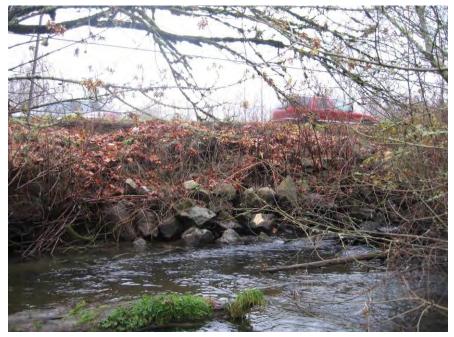
Figure 6. Union River, downstream from bridge, eroding highway embankment.

The second failure is the erosion of the embankment downstream from the bridge. The cause is ongoing channel migration, and the mechanism, or trigger, is debris spanning the stream channel, forcing side channels against the road embankment. The farthest side channel to the right impinges on the embankment, removing lateral support for the fill prism. The integrity of the pavement is threatened.

Under this alternative, standard maintenance and repair practices would be followed. The road embankment would be repaired by removal of fill dirt and installation of rock riprap, sized appropriately for the hydraulic conditions at the site. Riprap would protect the toe of the embankment from erosion due to the river. Mitigation would be required for loss of riparian habitat and/or wetlands. Installation of riprap would cause scour and transfer of stream energy downstream, accelerating erosion in areas not protected. Because there are several places where the river is encroaching on the road embankment, additional repairs, possibly extensive, would be anticipated. Aggradation of the river at this site could render these repairs useless.

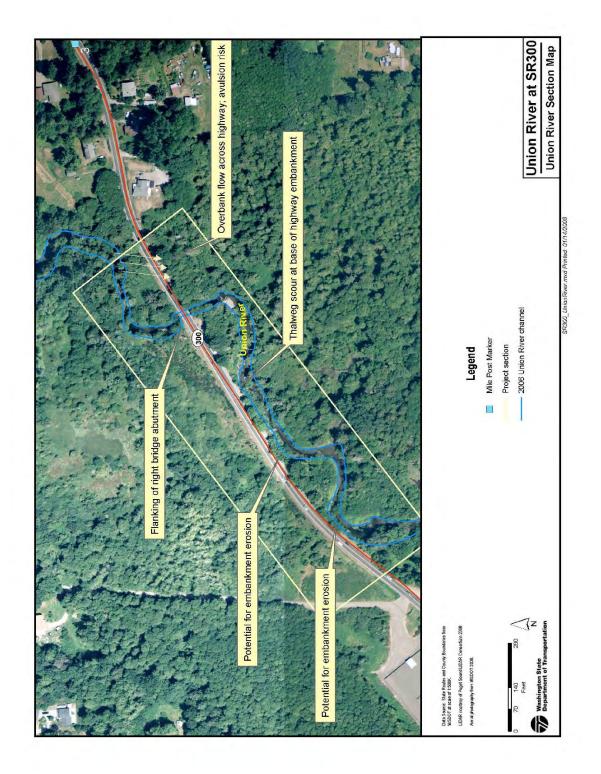
# Figure 7. Close-up of Union River Section with annotated features.

The first type of failure is not a geomorphic failure, but rather a design failure. The Union River bridge acts as a sieve for debris. The bridge deck is placed low, and the pilings are closely spaced. Additionally, the cottonwood tree immediately upstream from the bridge (see Figure 3) appears to help funnel wood debris toward the left bank during floods. The upstream meander is outflanking the constriction caused by the bridge and is impinging on the highway embankment. Furthermore, there is a risk of avulsion at the meander upstream from the right of way. Several small channels in the upstream floodplain aim at the highway east of the bridge. During the flood on December 3, 2007, the river flowed through these channels and over the highway immediately east of the bridge (see Figure 7).

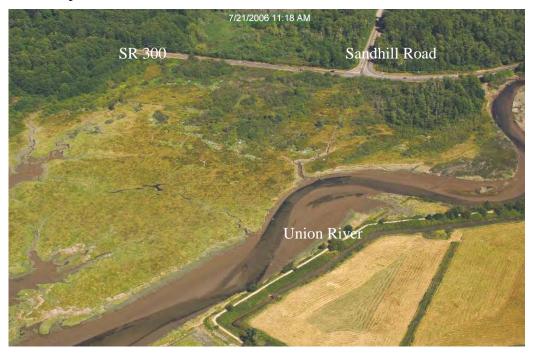
#### Figure 8. Wetland section of SR 300.

About 1000 feet west of the Union River Bridge, SR 300 crosses a wetland complex on fill (Figure 8). This section is defined by the length of highway that bisects the wetlands, between approximately MP 2.0 and 2.35. The road is periodically flooded in this section, closing off access to communities to the west. Additionally, there is damage (cracking, dips) to the pavement that is likely related to the saturated substrate. The wetland complex is part of the Union River floodplain and estuary. LIDAR imagery indicates that the river has occupied these areas before.

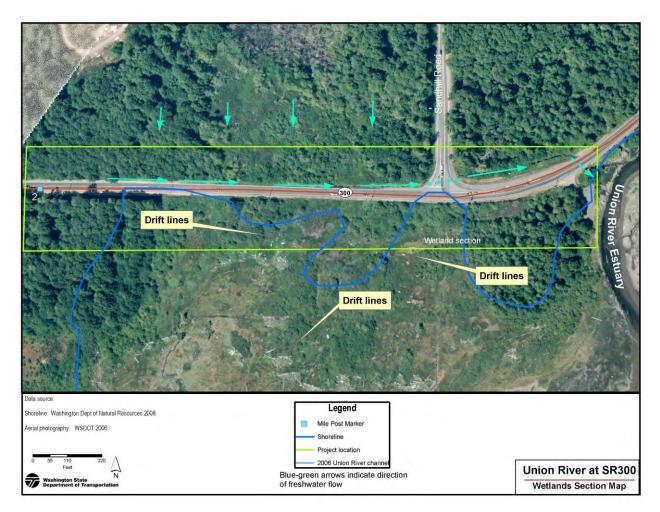
#### Figure 9. Wetlands section map.

Figure 9 shows a generalized picture of the runoff in the area. Drainage from the upstream side of the highway (the north side) is collected in a ditch that parallels the roadway. This ditch carries water eastward toward Sandhill Road, then under the road through two eight-inch culverts. East of Sandhill Road, an embankment approximately three feet high separates the ditch from the highway. The ditch leads to a culvert under the highway, which outfalls to the Union River estuary. The downstream side of the embankment has been shored up with steel sheet piling and quarry spalls, apparently due to sloughing of the road embankment when saturated.

The drainage ditch is variable in depth and width, ranging from one foot to more than three feet deep and up to 10 feet wide. Vegetation has encroached on the ditch crosssection throughout the length of the ditch between the west end of the wetlands (where the ditch begins) to Sandhill Road. On the south side of the highway lie the estuarine wetlands. During a site visit, the ditch was nearly full, while the estuarine wetlands had no standing water within 30 feet of the road embankment. The highway and the associated ditch divert water to the east that would otherwise flow diffusely out towards Hood Canal.

In the wetlands section of the site, interruption of the wetland flow paths and hydrology by the highway fill prism are the primary cause of flooding. In addition, the roadway surface is low, making it susceptible to flooding. The road base traverses a large wetland complex and is probably underlain by peat soils that provide a poor road foundation. Although no hydrogeologic data have been collected, it is likely that subsurface and surface flow used to be directed to the southwest. The highway was built perpendicular to the flow direction. There is only one culvert allowing water to pass to the southwest, and this is located after it flows underneath Sandhill Road. The road bed does not appear to allow any passage of water through seepage. Shortly after the flood of December 3, 2007, the water level on the north side of SR 300 was clearly higher than the south side. Along the north side, the drainage ditch was filled to capacity with water (see Figure 9).

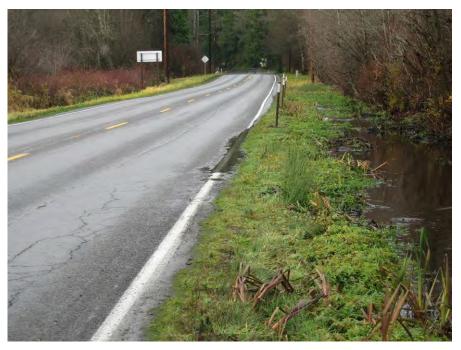
The pavement of SR 300 was only a few inches above the water in the ditch during the site visit on December 4, 2007 (Figure 10). Grass on the south side of the road embankment had been flattened by water flow, and road closure signs had recently been in place across this section of the highway.

Figure 10. Ditch along north side of SR 300 in the wetland section.

Note water on pavement.

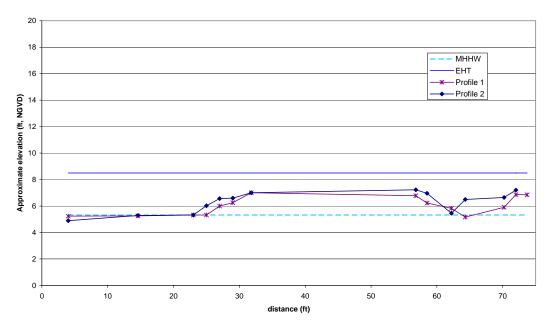
#### Figure 11. Elevation profiles across SR 300, wetlands section.

Elevation profiles were surveyed across the highway at two locations in the wetlands section in January, 2008. These profiles are located approximately 200 and 300 feet west of the intersection with Sandhill Road. We set the elevation of the pavement equal to the USGS benchmark at the Sandhill Road/SR 300 intersection (7 feet NGVD1927). Comparing the elevation of the roadway to the mean higher high water (MHHW) and extreme high tide (EHT) from the tide gage at Union on Hood Canal, we find that the roadway is only 1.5 feet above MHHW, and is entirely below the EHT (Figure 11). This information is consistent with the observation of the presence of *Carex lyngbyei*, a salt tolerant sedge, adjacent to the highway on the south side. It is also consistent with the shoreline layer compiled by the Department of Natural Resources, which is shown in Figure 9. In addition, in aerial photographs, drift lines can be seen near the highway. This debris was carried into the estuarine wetlands by high tides. WSDOT maintenance supervisor Larry Deemer states that the highway floods under EHT conditions, even without other factors.

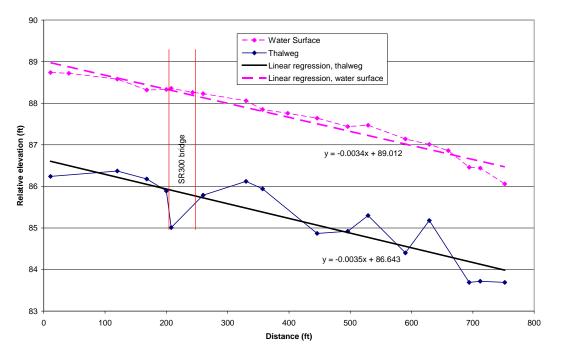
Longitudinal Profile

The longitudinal profile of the reach is shown in Figure 16. We fitted a trend line (based on linear regression) to both the water surface profile and the thalweg profile. The slope, based on the regression equation, is about 0.0035. The water surface slope was slightly lower, at 0.0034, however, this is within the amount of error associated with the survey technique used. Both the water surface slope and the thalweg slope increase rapidly at the downstream end of the surveyed profile. This corresponds to where the thalweg has migrated against the road prism. The thalweg profile also exhibits a drop at the bridge, suggesting constriction scour.

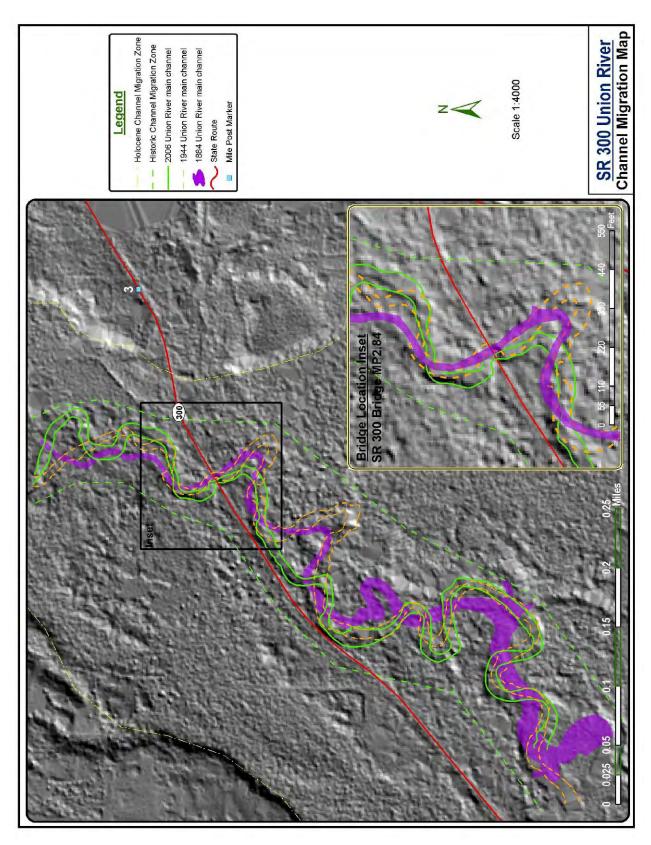
Figure 17. Union River Channel Migration 1884 to 2006.

Figure 17 shows the channel planform change over time. The earliest available survey is from 1884 (US Coast and Geodetic Survey 1884). We compared the planform from the 1884 shoreline map to 2006 aerial photographs. The channel has not migrated a great deal in over 120 years. A maximum of 150 feet of channel change was measured from the channel migration map. The greatest amount of migration occurred at the outside of meander bends that had migrated in the down-valley direction.

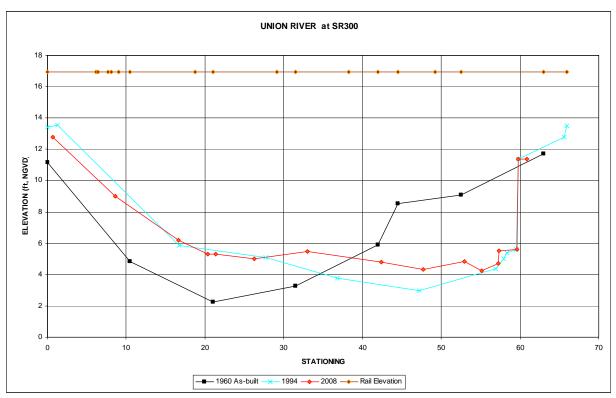
The most recent bridge survey was conducted in 1994. The results are shown in Figure 18. While the survey done for this study is not at the same level of accuracy as those of 1994 and 1960, it is useful to show general patterns of scour and deposition. Surveying of the west abutment, a concrete wall, matched the 1994 survey quite well. The cross-sections show that over the last 48 years, the channel thalweg has migrated to the right, up against the western abutment. In addition, the channel appears to have aggraded by as much as three feet in places. It is also important to note that the western abutment was not part of the original design. There have been no reported scour problems at the bridge.
